FACILITIES CONDITION ASSESSMENT

15. Facilities Condition Assessment

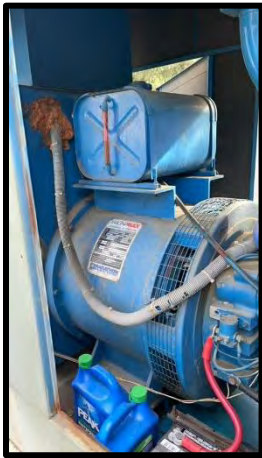
SITE	Electrical	Emergency Generator	Generator works. Does not have proper filter for the smoke released by generator. Generator located next to residential housing. Aged generator but functional. Generator is US Motors, but the synchronous ac generator shows its own nameplate with a manufacturer name of Magnamax.

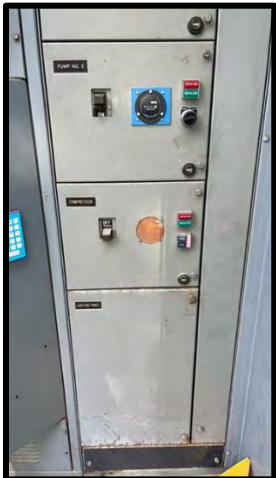
SITE	Electrical	MCC	No major issues communicated by the operator. Aged equipment. Lighting panel section is empty, lighting panel is in another section of the enclosure. Arc flash labels for the equipment are missing or outdated

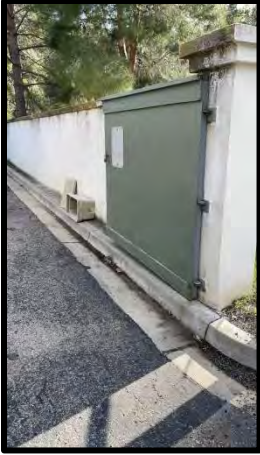
SITE	Civil	Entrance Gate	Aged and deteriorated

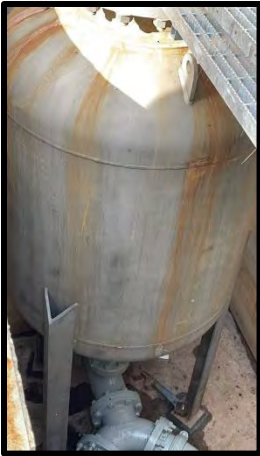
VAULT	Structural	Bladder Surge Tank	Sign of corrosion on the tank. Some issues with surge tank, no level indicator.

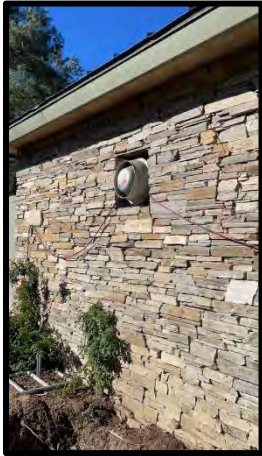
PUMP ROOM	HVAC	Pump Room Exhaust Fan	4	<p>The location of exhaust fan is ok. A supply fan needs to be installed to discharge air flow in dry well. The power is also low and cannot ventilate the air. Frame is heavily corroded. The extension cords on the outside of the building should be relocated internal to the building to avoid being vandalized</p>

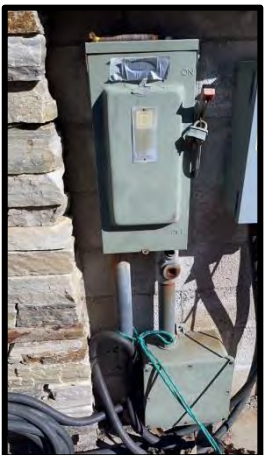
SITE	I&C	Submersible Pump #1 Disconnect Switch	4	<p>Evidence of physical damage, overheating, corrosion, or other deterioration - there is obvious code issues - Operator indicate issues with the operation or finding parts to maintain the equipment</p>

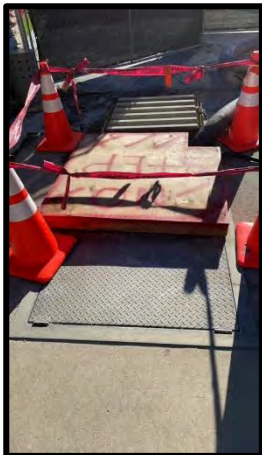
WETWELL	Structural	Wetwell Structure and Access Hatch-Round Shape	4	Coating failed. Access hatches mechanism is not appropriate. Access hatches frame heavily corroded. No ladder

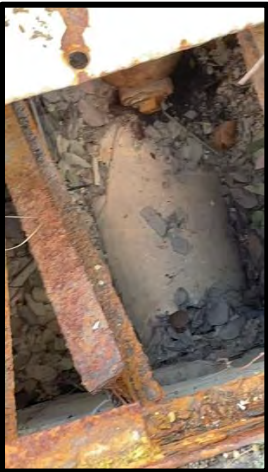
AIR RELEASE VAULT	Mechanical	Piping in Vault	4	Force main pipe cannot be visually inspected because of dirt around it and for assessment of confined-space entry is needed. The condition score is based on the adjacent assets.

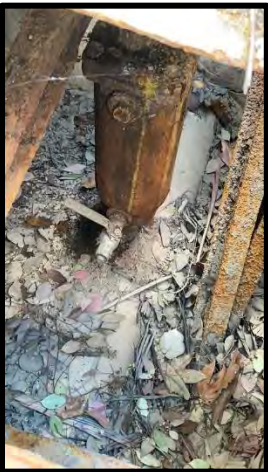
AIR RELEASE VAULT	Mechanical	Air Release Valve	5	Heavily corroded. Doesn't look functional.

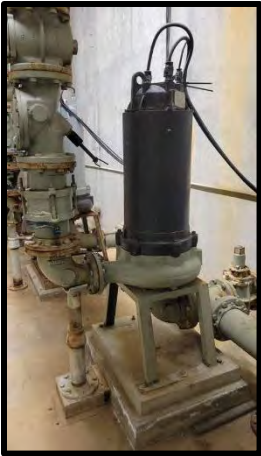
PUMP ROOM	Mechanical	Pump #3	4	District has already purchased new pumps to replace existing pumps.

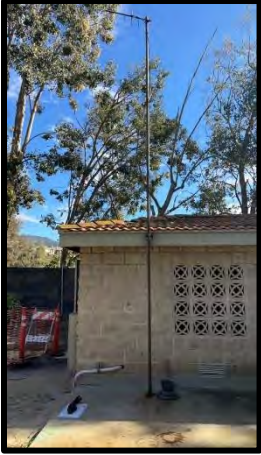
SITE	I&C	Telemetry Radio	4	A lot of corrosion present. Telemetry radio connected to SCADA.

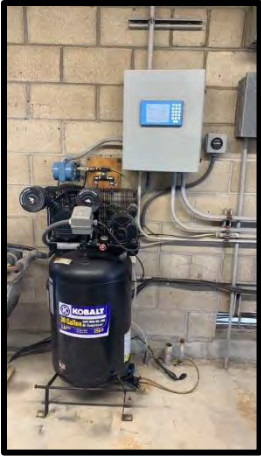
SITE	I&C	Wetwell Level Transmitter	4	Bubbler is functional; however, station lacks redundant level indicator of wet well. Operators would prefer redundant level instrument and high-level float

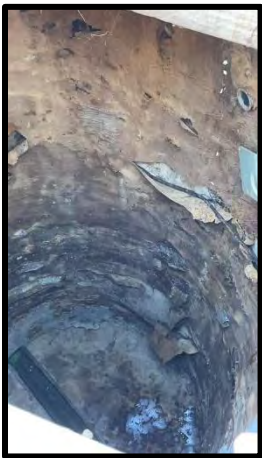
OLD WETWELL	Structural	Old Wetwell Structure	4	Coating failed. It is being used as emergency storage. No ladder. Access hatch frame corroded

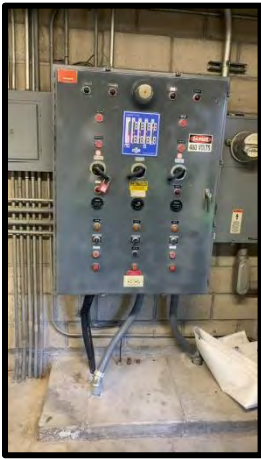
CONTROL ROOM	I&C	Control Panel	4	Arc flash labels for the equipment are missing or outdated - Operator indicate issues with the operation or finding parts to maintain the equipment

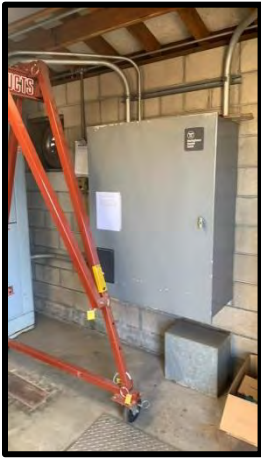
CONTROL ROOM	Electrical	Automatic Transfer Switch	5	Operator mentioned that ATS has issues when transferring between utility and generator power. Obsolete and discontinued parts - arc flash labels for the equipment are missing or outdated

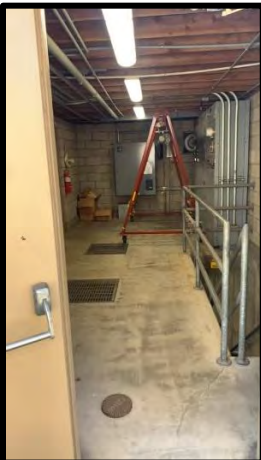
CONTROL ROOM	HVAC	Building Exhaust Ventilation	5	Lift station building likely considered as a hazardous/classified area due to lack of proper ventilation. Investigate NFPA 820 and recommend go/no-go light.

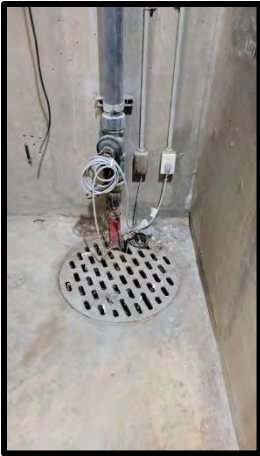
PUMP ROOM LS	Mechanical	Sump Pump	4	Approaching the end of it's useful life due to age - corroded

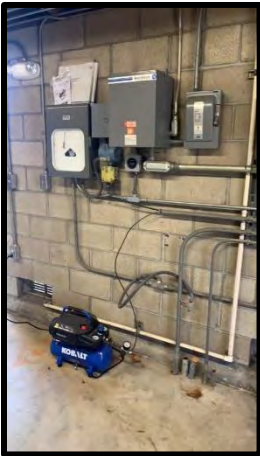
SITE	Mechanical	Wetwell Level Transmitter	4	<p>Bubbler is functional, but there is no level instrument redundancy. If loose bubbler, no backup signal.</p> <p>Operations would like a redundant level instrument, such as ultrasonic or radar; and high float to turn pumps on if necessary / LIT info is not accessible/visible and may not be used, as would be another level indicator in LS control panel</p>

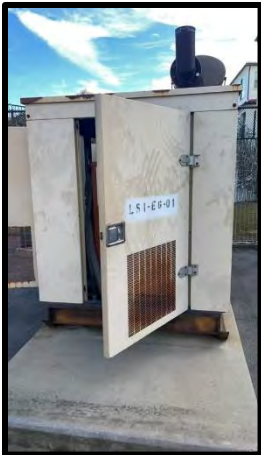
SITE	Electrical	Emergency Generator	4	<p>There is some corrosion present. Grandfathered generator is rated Tier 1.</p> <p>Generator is nearby residential housing. Smoke coming out from generator could be a hazard.</p> <p>Generator replacement should be tier 4/have proper filter for smoke.</p>

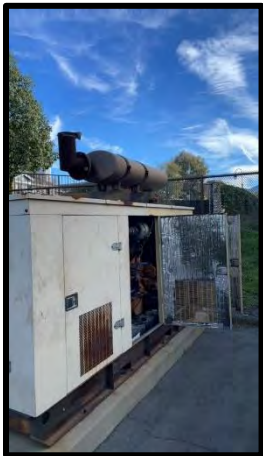
SITE	Mechanical	Engine Exhaust Silencer	4	Heavily corroded. Produces black smoke

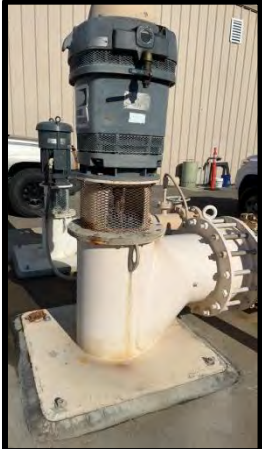
BACKWASH	Mechanical	Filter Plant Back Wash Sump Pump #1 (Large-40 hp)	Rehabbed in 2016, at the end of useful life, rusted and corroded.
2

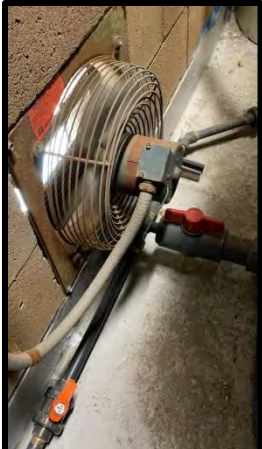
CHLORINE BUILDING	HVAC	Exhaust Fan Chlorine Building	Heavily corroded. Exhaust needs to be more powerful for the area to meet fire code required air exchanges per hour.
3

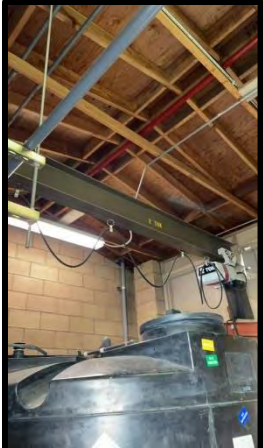
CHLORINE BUILDING	Structural	Chlorine Building Structure	Several defects on the roof. Back door severely corroded.
5

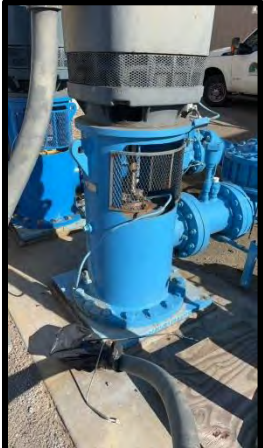
CLEARWELL	Mechanical	Effluent Pump#2 Near Clearwell	Rusted and corroded, In need of rehabilitation. Will be rehabbed after pump#1
6

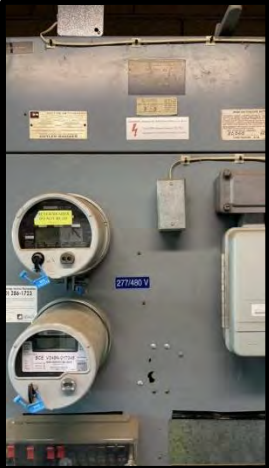
ELECTRICAL ROOM	Electrical	Main Service Switchboard	Evidence of physical damage, overheating, corrosion, or other deterioration - there are obvious code issues
8

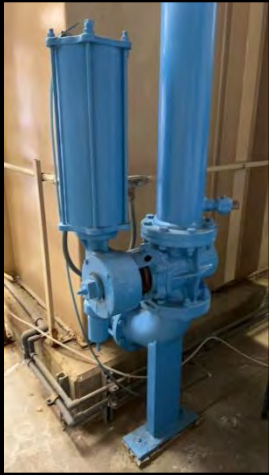
FILTER BUILDING	Mechanical	Filter Plant Filter #4 Air Scour Valve	Approaching the end of its useful life due to age
9

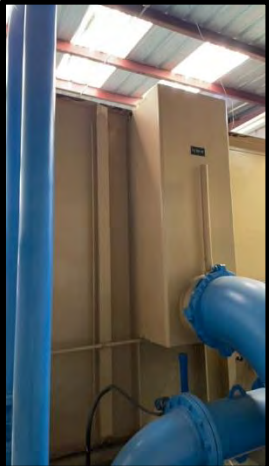
FILTER BUILDING	Structural	Filter Plant Filter #4 - Structure	Heavily corroded. Requires coating.

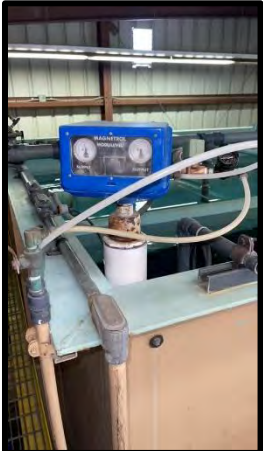
FILTER BUILDING	I&C	Filter #4 Level Instrument	Evidence of physical damage, overheating, corrosion, or other deterioration

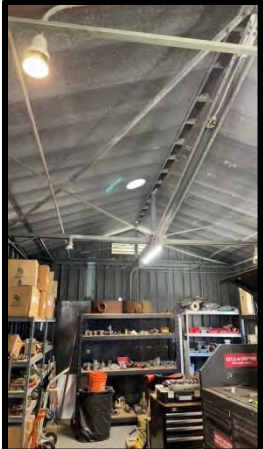
MCC ROOM	Electrical	Lighting For MCC B Building	The interior lighting needs improvement. Many of the fixtures are not in good condition.
14

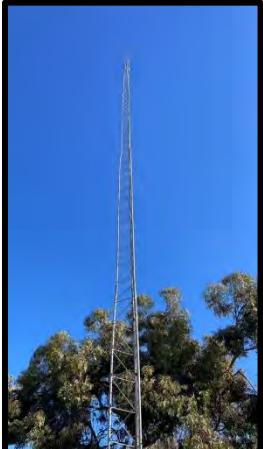
SITE	I&C	Antenna Tower for SCADA	Tower legs heavily corroded.

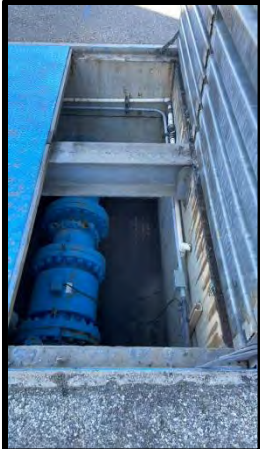
SITE	Structural	Effluent Meter Vault	No sump pump in the vault. Some diagonal cracks near pump connection to the concrete. Access hatches need to be replaced. Require sump pump.
17

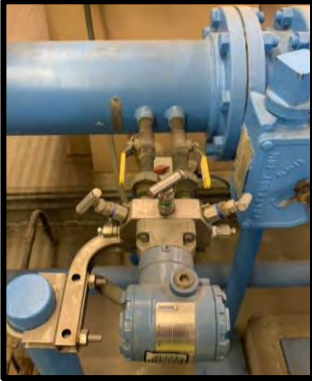
FILTER BUILDING	I&C	Filter Plant Filter #1 Flow Meter	Filter differential pressure flow meters do not function properly and need replacement - Meter doesn't work anymore but they get a reading close to the accurate number (per operator)
3

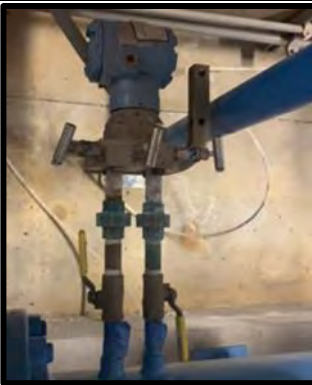
FILTER BUILDING	I&C	Filter Plant Filter #4 Flow Meter	Likely DP2051 model similar to filter 1, but unable to confirm from nameplate - Operations stated these flowmeters do not provide accurate readings and need replacement

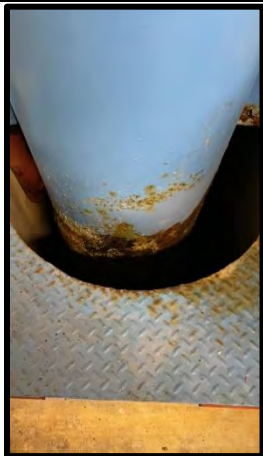
FILTER BUILDING	Mechanical	16 In Piping for Filter #4	Heavily corroded. Leakage
8

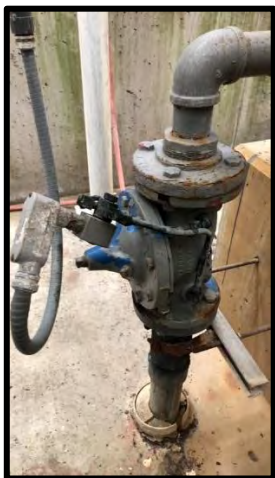
BELT PRESS BUILDING	Mechanical	Isolation Valve Old Pump#1 - Mid Floor - West	Current functionality is unknown. Approaching the end of it's useful life due to age, corroded, and deteriorated.

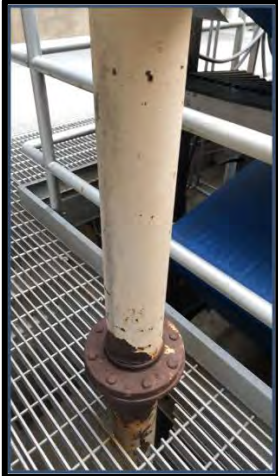
BELT PRESS BUILDING	Mechanical	Piping - Upper & Lower Level	Leakage, vibration, corrosion, and deterioration were observed.
4

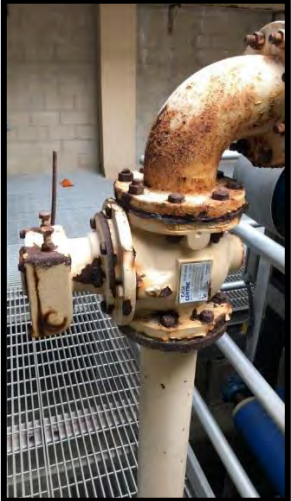
BELT PRESS BUILDING	Mechanical	Belt Press Plug Valve	Leakage, vibration, corrosion.
5

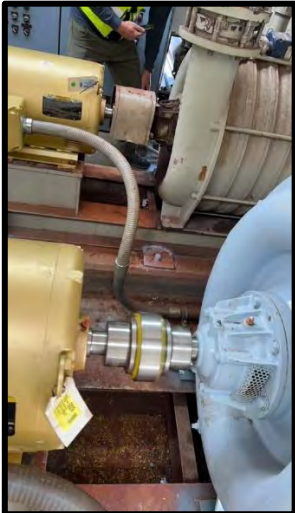
BLOWER ROOM	Mechanical	Blower Upper Level - West	No shaft cover (Safety Issue)
8

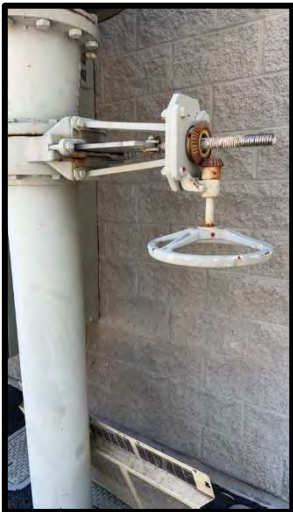
BLOWER ROOM	Mechanical	Valve - With Handwheel Operator - Blower Room Outside	Record drawing states this is for foul air. Inoperable due to rust.
11

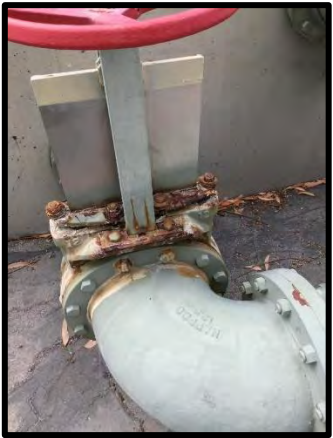
CHLORINE CONTACT CHAMBER	Mechanical	Fourth Chamber Knife-Gate Valve - Handwheel Operated Urethane - Downstream Bend	Operations report it does not work due to corrosion, deterioration.
17

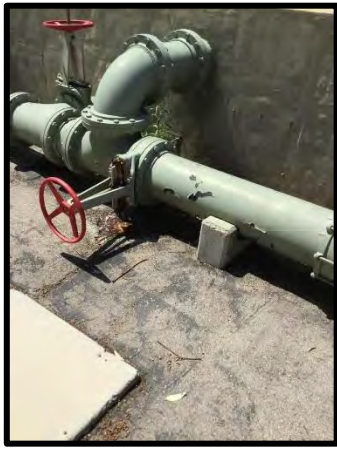
CHLORINE CONTACT CHAMBER	Mechanical	Chamber 1 Bypass Valve	Leakage and vibration were observed. Severe corrosion. Inoperable due to corrosion and deterioration.
18

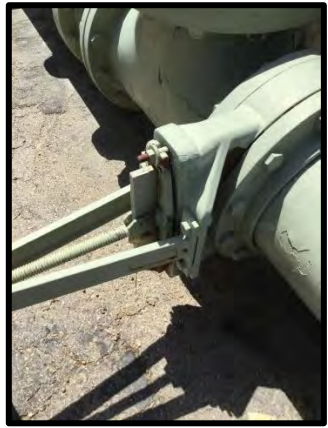
CHLORINE CONTACT CHAMBER	Mechanical	Chamber 2 Bypass Valve	Some corrosion observed. Operations reports valve does not work due to corrosion and deterioration.

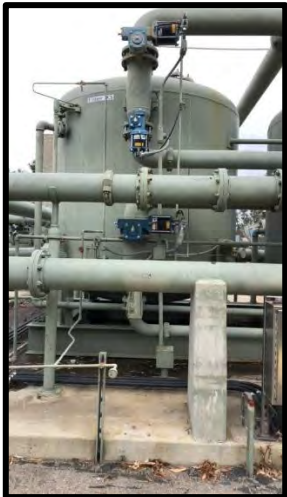
FILTERS	Mechanical	Filter#3 Drain Valve - Air Actuated	Installed in 1988 - at the end of service life. Corroded and deteriorated.
23

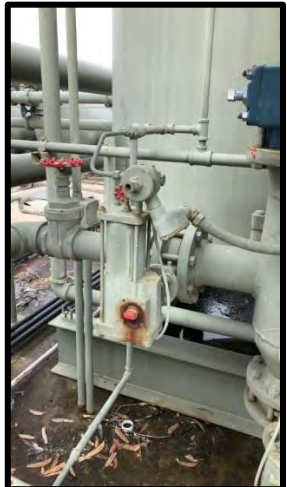
FILTERS	Mechanical	Filter#3 Effluent Valve	Original equipment - at the end of service life. Corroded/deteriorated.
24

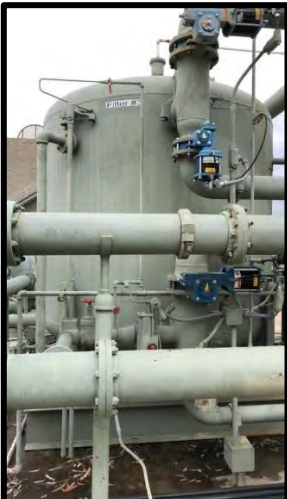
FILTERS	Mechanical	Filter #3 Effluent Isolation Valve - Manual	Leaks/broken/corroded/deteriorated.

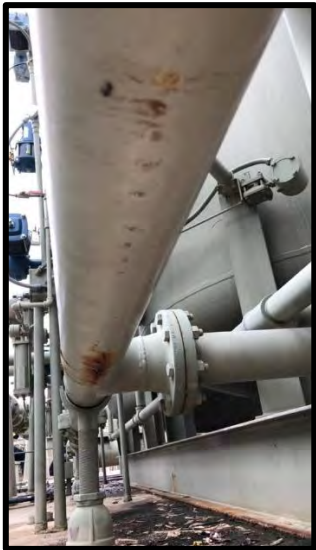
FILTERS	Mechanical	Filters Drain Line	Leakage and corrosion were observed, especially at the bottom. Only leaks when the filters are being drained.
26

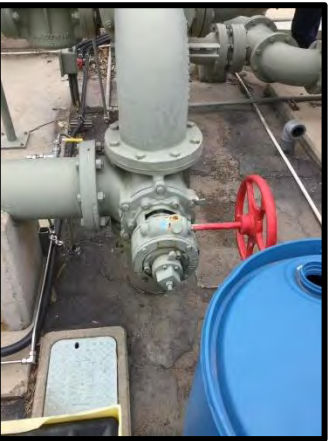
FILTERS	Mechanical	First Filter System Inlet Valve	Valve is inoperable and is leaking internally.

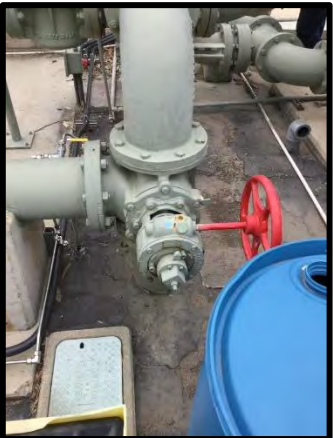
FILTERS	Mechanical	Main Filter Inlet Valve	Valve is broken and is leaking internally.
29

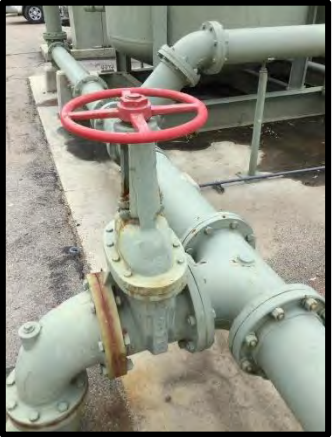
FILTERS	Mechanical	Filter Bypass Valve	Slight corrosion/deterioration observed. Valve not in use.
30

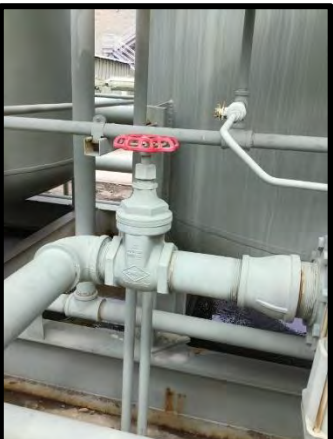
FILTERS	Mechanical	Filter#2 Manual Isolation Valve	Valve stuck open. Leaking internally.

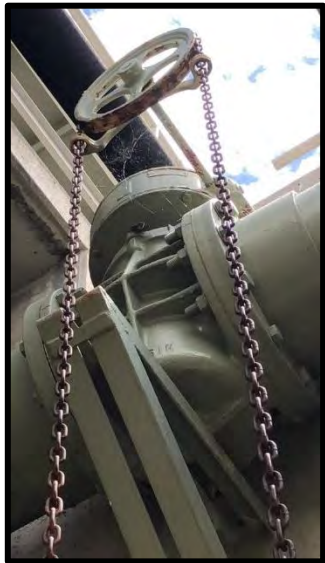
REACTOR DRYWELL	Mechanical	Chainwheel Valve - Eccentric	Valve only moves with excessive force. Corrosion/deterioration observed.
33

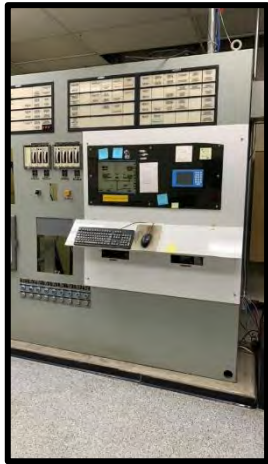
LAB - BUILDING C	I&C	Old Scada System	<p>Replacement parts unavailable/difficult to obtain. Control panel required troubleshooting in 2020. Pilot lights shows signs of sun degradation. Enclosure recently replaced but inside is original.</p>
39

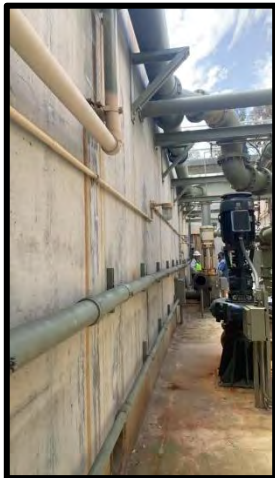
REACTOR DRYWELL	Electrical	Dry Well Lighting	<p>Only 3 of 9 fixtures turn on when switched, other 6 appear not to be functional. The switches for the working lights not up in the on position. Recommend replacing with LEDs</p>
40

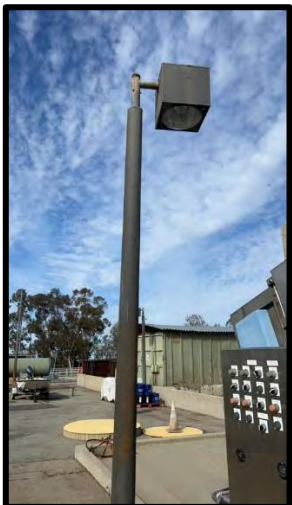
SITE	Electrical	Site Lighting	<p>15-20' high pole mounted fixtures are scattered across site. Some poles show signs of corrosion/deterioration. Fixtures are old and original – only about 50% work. Recommend replacement with LEDs. (Approx. 15 fixtures)</p>

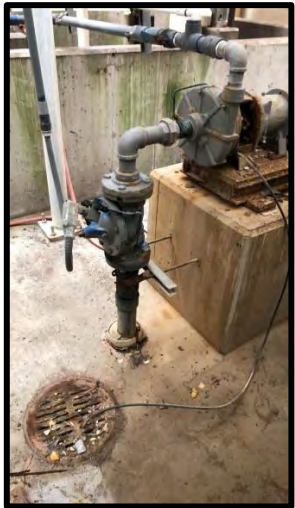
BELT PRESS BUILDING	Structural	Floor Drain	<p>No longer drains. Leaking fluid from an old, nearby pump corrodes this and other nearby components. Floor also does not appear to slope toward drain. Standing water under belt press.</p>
42

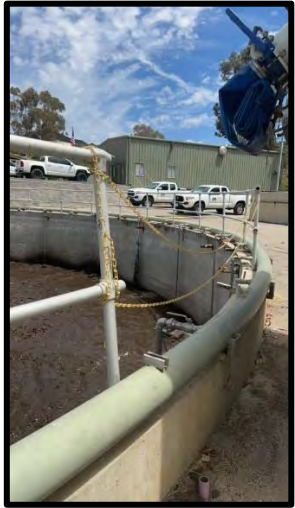
DIGESTER	Structural	Digester Handrail and Catwalk	<p>Catwalk is not safe, and handrail is missing in some areas (Safety Issue).</p>
43

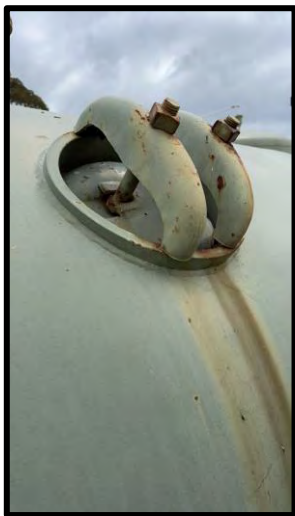
FILTERS	Civil	Filter#1,2,3,4,5,6 Tank	<p>The tank body is pitted and corroded. Drainage underneath tanks is not good. Air scouring of the tank does not work at all due to broken pump. Surface coating of the tank due to rain cascading impact is being damaged. Filter media replacement orifice is corroded and not sealed and causes issues. Backwash takes an hour/day as the valves have to be operated manually.</p>

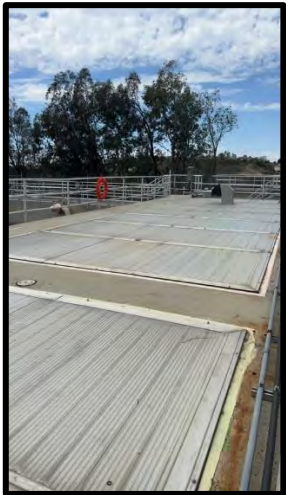
INFLUENT EQUALIZATION BASIN	Structural	Structure - North/South Influent Equalization Basin and the Aluminum Cover	cleaning issue, minimal slope, hard access and bad drains, the cover is corroded and deteriorated and unsafe.
45

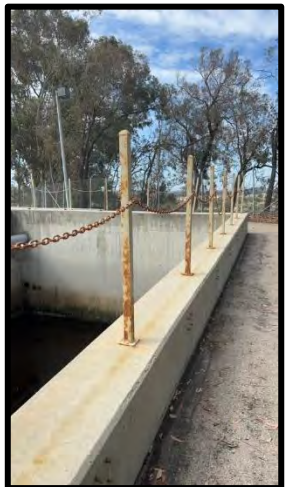
SITE	Civil	Stairway - Handrails - Catwalk (the Reactor Drywell, SBRs, Secondary Effluent Equalization Basin)	not sufficient handrails around the West-SBR and the secondary effluent equalization basin - safety issue
