FACILITIES CONDITION ASSESSMENT

15. Facilities Condition Assessment

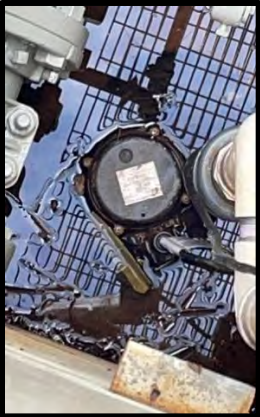
VAULT	Mechanical	Sump Pump	Pump is not under ideal operating condition and doesn't fully drain the vault.

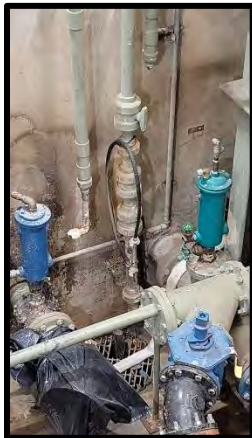
PUMP ROOM	Mechanical	Pump Room Sump Pump	5	Not reliable

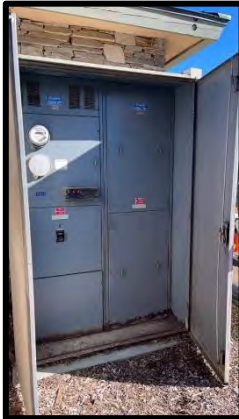
SITE	Electrical	Main Service Switchboard	5	<p>Evidence of physical damage, overheating, corrosion, or other deterioration - there is obvious code issues - arc flash labels for the equipment is missing or outdated</p>

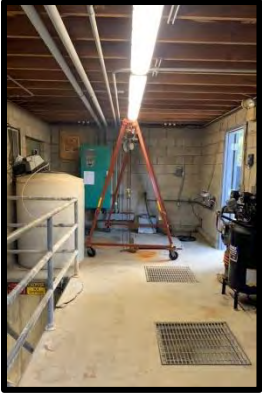
BUILDING	HVAC	Ventilation	5	Station is not constantly ventilated and has no indication to comply with NFPA 820, without ventilation this space is classified as class I div 2 spaces. Recommend installing go/no-go lights in compliance with NFPA 820

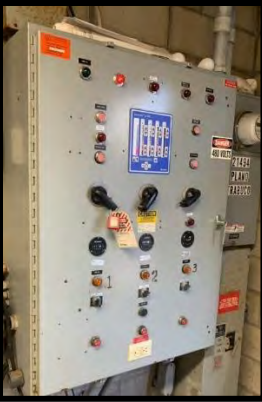
CONTROL ROOM	I&C	Control Panel	5	Rust present on the enclosure - arc flash labels for the equipment missing or outdated - Operator indicate issues with the operation or finding parts to maintain the equipment

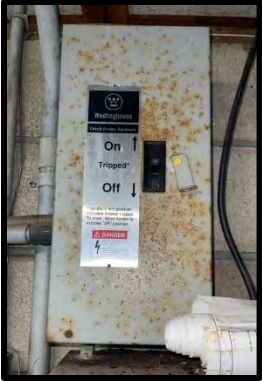
CONTROL ROOM	Electrical	Transformer Circuit Breaker	4	Appearance exhibits quite heavy amount of corrosion.

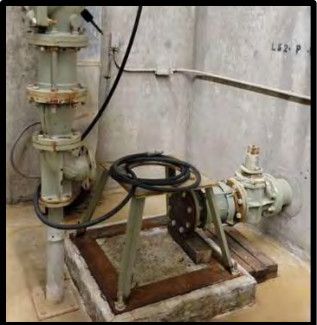
PUMP ROOM	Mechanical	Pump #1	5	District has already purchased new pumps to replace existing pumps.

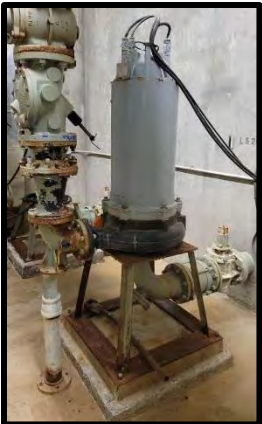
PUMP ROOM	Mechanical	Pump #2	4	District has already purchased new pumps to replace existing pumps.

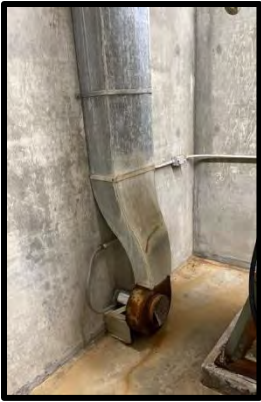
PUMP ROOM	HVAC	Control Room and Pump Room Exhaust Fan	4	Heavily corroded and loud noise is produced when functioning

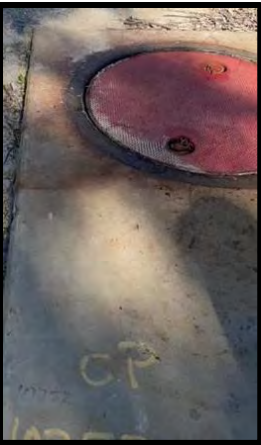
SITE	Structural	Secondary Wetwell Manhole	5	This manhole allows secondary manhole for bypassing the wetwell. Based on the operator's comment, it has design issue and is already under rehabilitation. Confined-space entry is needed and can't be visually inspected.

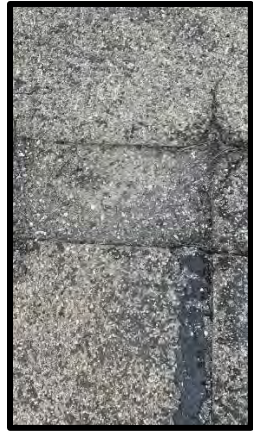
SITE	Civil	Pavement	4	Several cracks and the asphalt is peeled off in some spots.

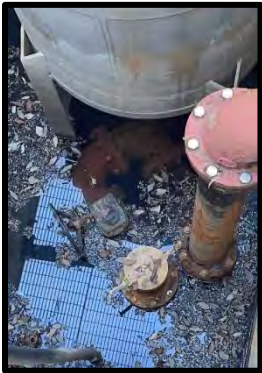
SURGE TANK VAULT	Mechanical	Sump Pump for Surge Tank Vault	5	It seems to be failed and cannot discharge water.

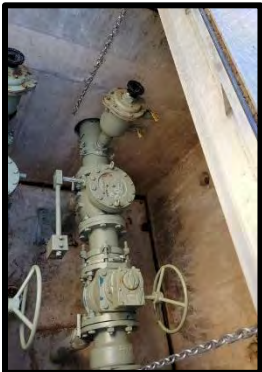
VALVE VAULT	Mechanical	Air Release Valve Pump #1	5	Valves are air-vac, cause slam and excessive noise during pump startup. Top of valve blew off and ball failed to seat, flooding vault. Currently closed. Operators want air release only, non-re-entry. Alternative is to use non-slam air-vac.

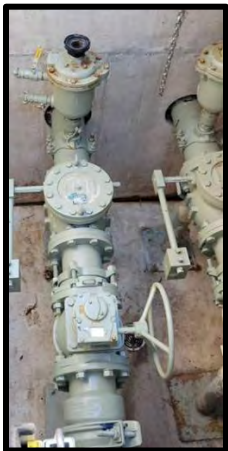
VALVE VAULT	Mechanical	Air Release Valve Pump #2	5	Valves are air-vac, cause slam and excessive noise during pump startup. Top of valve blew off and ball failed to seat flooding vault. Currently closed. Operators want air release only, non-re-entry. Alternative is to use non-slam air-vac.

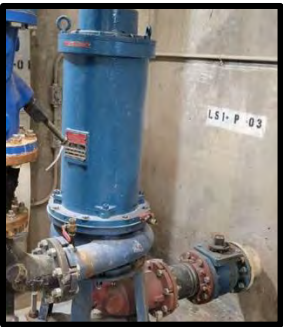
PUMP ROOM LS	Mechanical	Pump #1	5	Wall label does not match controls. Pump is not functional.

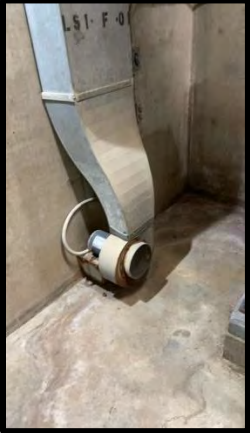
LOWER LEVEL	HVAC	AC Unit Exhaust Fan	4	Sign of corrosion on corresponding assets - motor produces noise

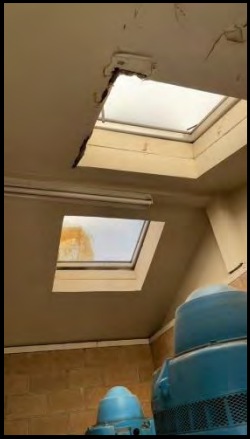
SITE	Structural	Pump Room Building Structure-Sky hatch Lighting Source	4	Leakage from roof near skylight shades - Crack on the side seems to be foundation related issue

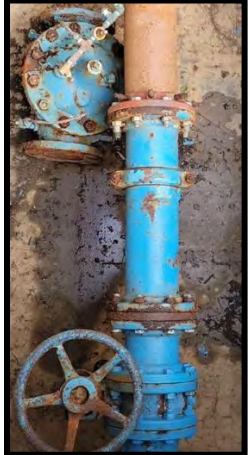
SITE	Mechanical	Flow Control Valve #2 - 6	5	Removed from service at the moment but needs to be replaced. They currently use a butterfly valve. Paint chipped, bonnet bolts rusting

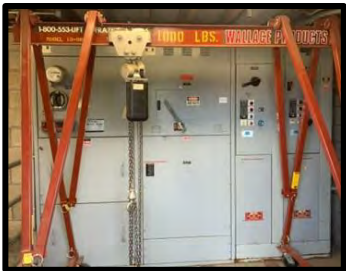
CONTROL ROOM	Electrical	Main Switchboard	4	Building needs to be checked for compliance with NFPA 70E. Corrosion ok. Present SWBD only rated for 14ka short circuit, short circuit analysis should be performed to check if this exceeds available fault current. No arc flash labels on any electrical equipment on site - Motor starter within SWBD is by Digifire, this company is out of business as per maintenance staff - 3'4" clear from SWBD to ATS, likely NEC working space violation. Crane also located in front of switchboard currently

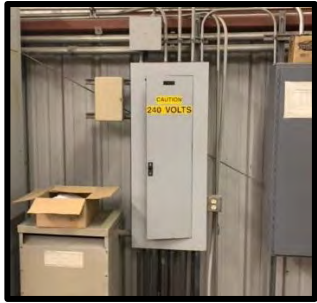
FILTER BUILDING	Electrical	Lightening Panel LP-A	Amperage of panel is based on main breaker size - Nameplate of panel is missing - arc flash labels for the equipment missing or outdated
12

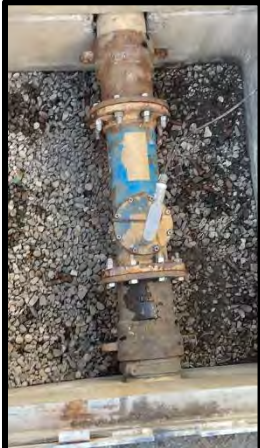
SITE	Mechanical	Waste Meter Vault Piping	The piping is heavily corroded
18

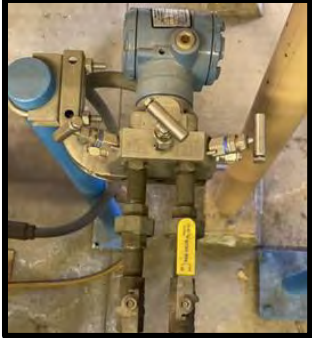
FILTER BUILDING	I&C	Filter Plant Filter #2 Flowmeter	Flow meter that calculates flow using differential pressure. They are not functioning now per operator.
2

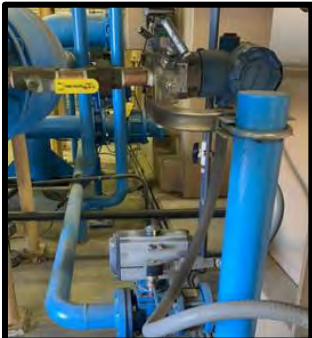
FILTER BUILDING	I&C	Filter Plant Filter #3 Flowmeter	Flow meter that measures flow using differential pressure. Meter doesn't work anymore but they get a reading close to the accurate number (per operator)
4

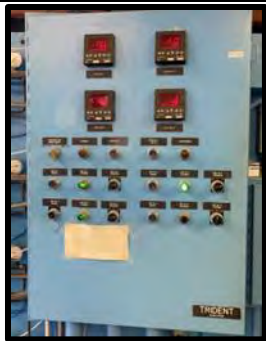
FILTER BUILDING	I&C	Filter Plant PLC-Controller	Operators indicate issues with the operation or finding parts to maintain the equipment

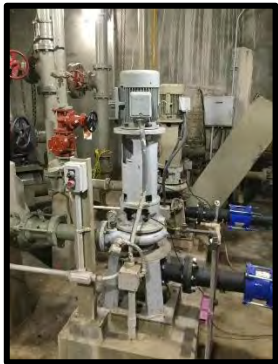
BLOWER ROOM	Mechanical	Pump#2 and Motor - Lower Floor	Shaft guard is missing (Safety Issue)

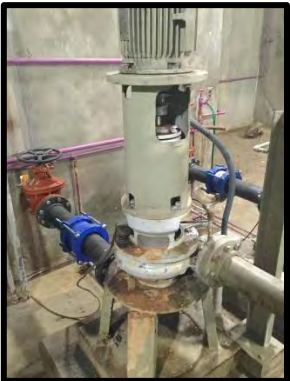
BLOWER ROOM	Mechanical	Pump#1 And Motor - Lower Floor	Shaft guard missing (Safety Issue). Leakage, excessive noise, heat, vibration was observed. Some corrosion to pump, moderate corrosion to pump base, and corrosion and deterioration to seals causing leaks
7

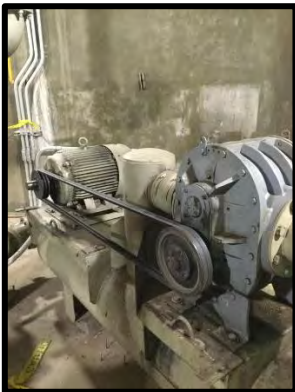
BLOWER ROOM	Mechanical	Blower LN - Lower Floor - Packaged Rotary - Motor - Silencers	Leaks, excessive noise, heat, and vibration were observed. Minor oil leak. Area caution taped / guard cover for belt is removed (Safety Issue)

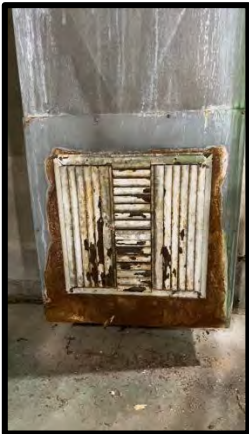
BLOWER ROOM	Mechanical	Air Ventilation System - duct - Lower Level	<p>Inoperable. Without ventilation, this could be classified as a confined space. There could be a leak of WAS from the pumps and there is a chance of developing a hazardous atmosphere.</p> <p>Also, the blowers generate heat so the space should have some air circulation.</p>
10

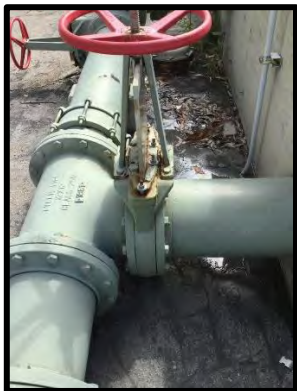
CHLORINE CONTACT CHAMBER	Mechanical	First Chamber Knife-Gate Valve - Handwheel Operated Urethane	Leakage, excessive noise, heat, and vibration were observed. Valve housing and packing are leaking. Operations reports valve does not work due to corrosion, deterioration.

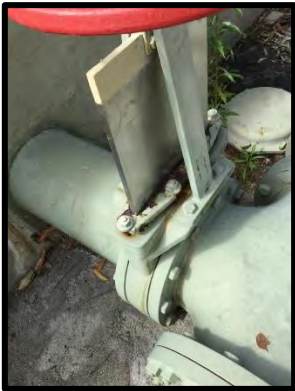
CHLORINE CONTACT CHAMBER	Mechanical	Second Chamber Knife-Gate Valve - Handwheel Operated Urethane	Operations reports valve does not work due to corrosion, deterioration.
13

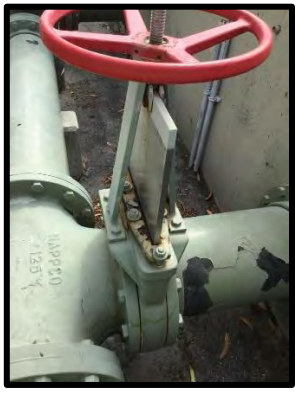
CHLORINE CONTACT CHAMBER	Mechanical	Third Chamber Knife-Gate Valve - Handwheel Operated Urethane	Operations reports valve does not work due to corrosion, deterioration.
14

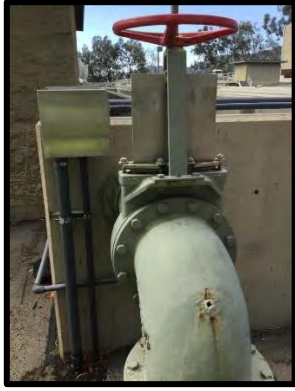
CHLORINE CONTACT CHAMBER	Mechanical	Effluent Knife-Gate Valve - Handwheel Operated Urethane - Chamber 4th	Operations reports it does not work. History of failure and maintenance.
15

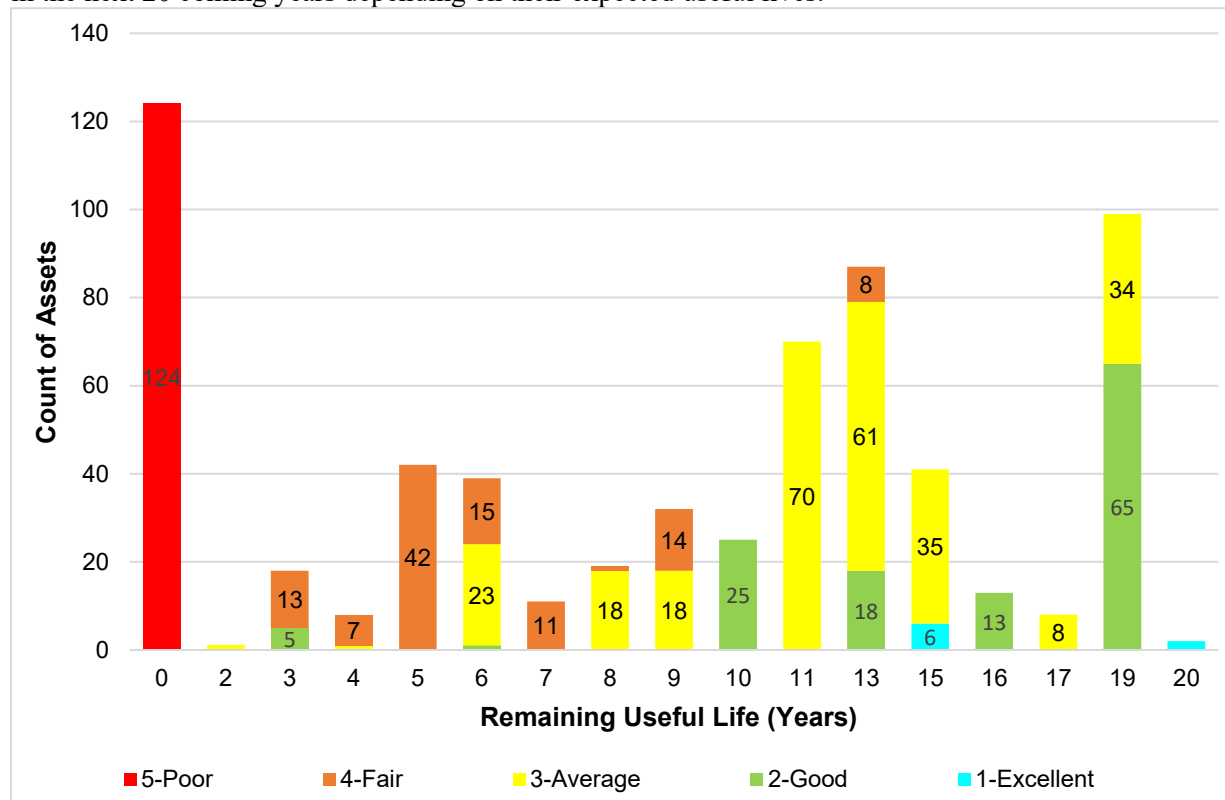
Figure 15-13: Summary of the Condition-based Remaining Useful Life Estimation

Figure 15-13 presents a summary of the condition-based RUL analysis results for the assets with condition scores assigned. This figure shows 124 assets, listed in poor condition for the facilities are at the end of their lives. In addition, some assets in fair, average, good, and excellent condition are in need of replacement in the next 20 coming years depending on their expected useful lives.

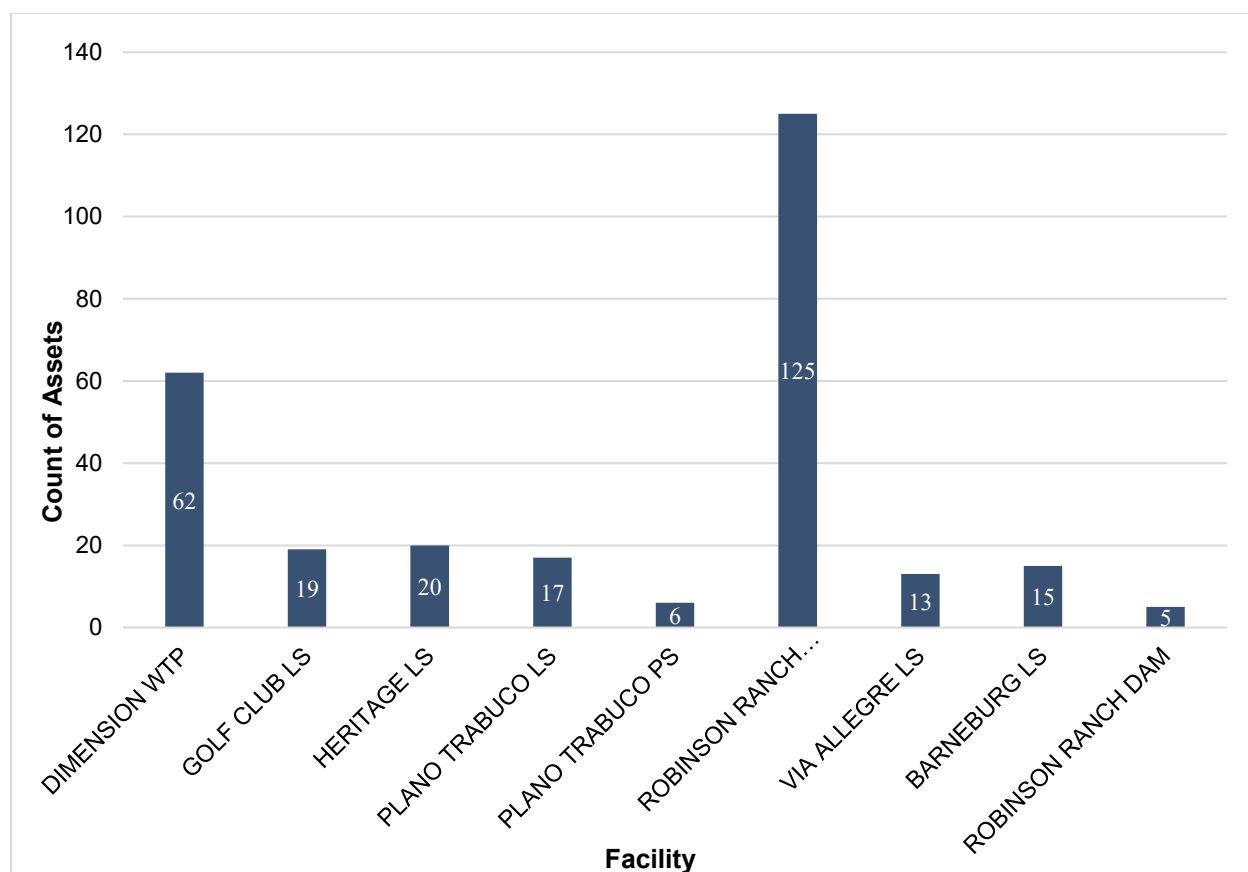
Figure 15-14: Assets Coming for Replacement in the Next 10 Years - Condition-based Approach

Figure 15-14 presents the number of assets in the visually inspected facilities coming up for replacement in the next 10 years based on condition scores.

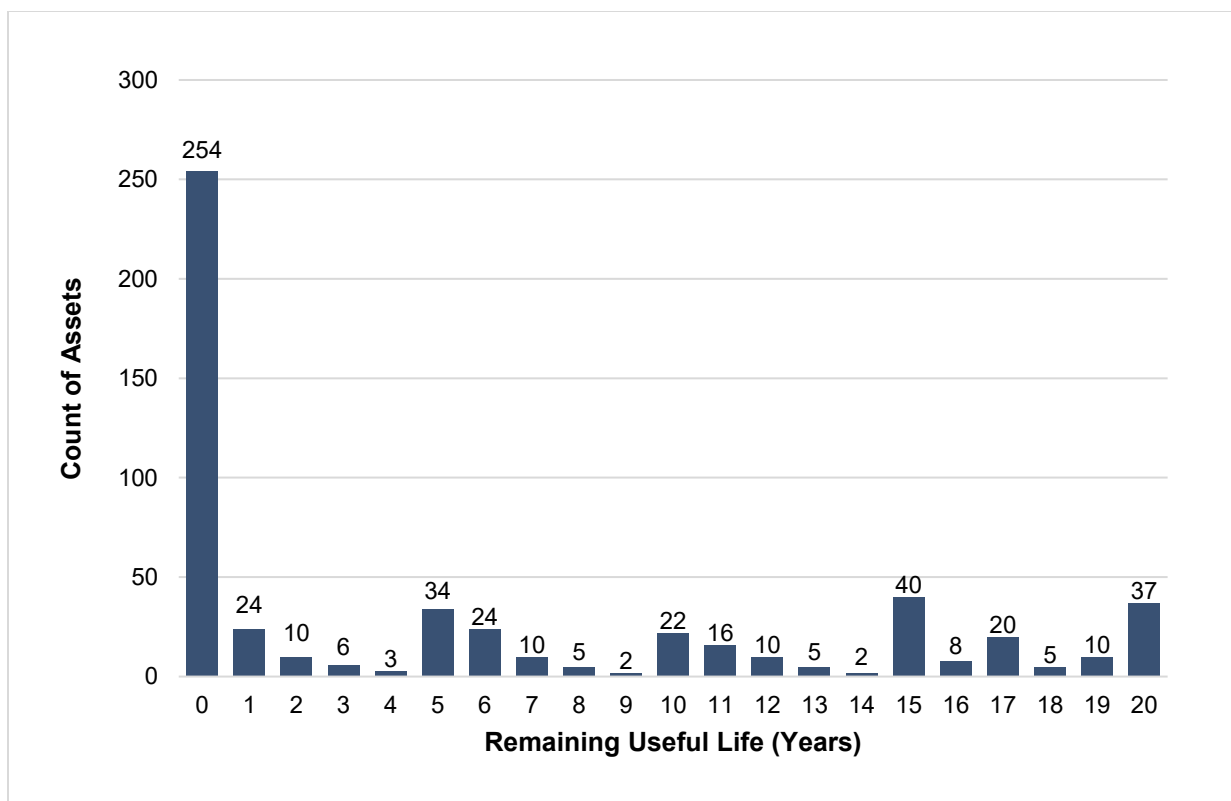
Figure 15-15: Summary of Remaining Useful Life Assessment Results - Assets without Condition Scores

Figure 15-15 presents a summary of the age-based RUL analysis results for the assets with no condition assigned. This figure shows the assets coming up for replacement in the next 20 years. As is evident from this figure, 254 assets are at the end of their useful life based on age-based method.
