**ENGINEERING/OPERATIONAL COMMITTEE MEETING AGENDA  
TRABUCO CANYON WATER DISTRICT  
32003 DOVE CANYON DRIVE, TRABUCO CANYON, CA  
VIDEO/AUDIO BROADCAST MEETING  
FEBRUARY 3, 2021 AT 7:00 AM**

ITEM 5: DISCUSSION AND POSSIBLE ACTIONS(S) CONCERNING THE DIMENSION WATER TREATMENT PLANT BACKWASH WASTE TANK REPLACEMENTS

January 2021 Update

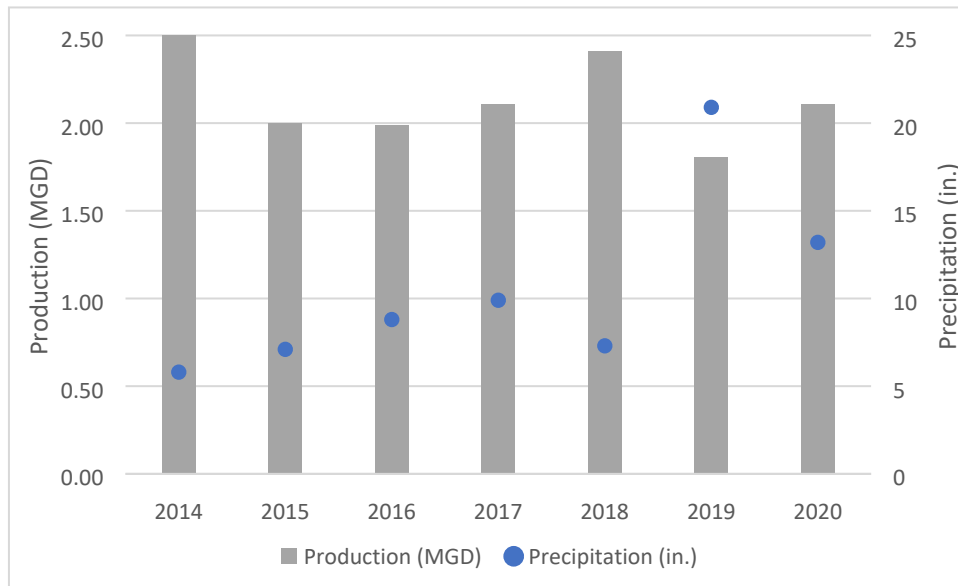
**Figure 2**  
**Average Domestic Water Production and Rainfall**

TCWD monitors its available storage on a daily basis taking into account that water levels fluctuate hourly based on system water demands and production rate. The number of available days of storage is calculated based on total storage and water demands or production. Over the past seven calendar years domestic water production has averaged 3.28 cfs, which is 6.55 acre-feet per day or 2.14 million gallons per day (MGD) as shown in Table 2 along with precipitation figures from the California Irrigation Management Information System (CIMIS) Station 75 in Irvine (Great Park). Figure 2 is a plot of this information, which shows the relationship between demand and precipitation. Although there has been some growth within the District over this period, demands are trending slightly downward, most likely due to continued conservation. It should be noted that the closest year to the average demand over this period occurred in 2017, which was also the closest year to the average rainfall over the seven-year period.

Assuming average production of 2.14 MGD from Table 2 and existing effective storage of 10.8 MG from Table 1, the District has just over 5 days of storage ( $10.8/2.14$ ). Using average production from 2019 of 1.81 MGD, would increase that to just under 6 days of storage. If, during an emergency, existing customers were to reduce water use to water demands of about 2.0 cfs or 1.29 MGD, then just over 8 days of storage would be available. Reducing demands to 2.0 cfs or even below that amount for a period of one or two weeks should be completely achievable as the total monthly production has been at or below this amount for the five full months shown in Table 3 during the past two winters. In fact, average production of about 1.35 cfs was recorded over the two-month period of February and March of 2019. Therefore, indoor-only water demands should be below 1.5 cfs, which should be attainable with effective communication to all District customers requesting they eliminate all non-essential irrigation during such an emergency condition.

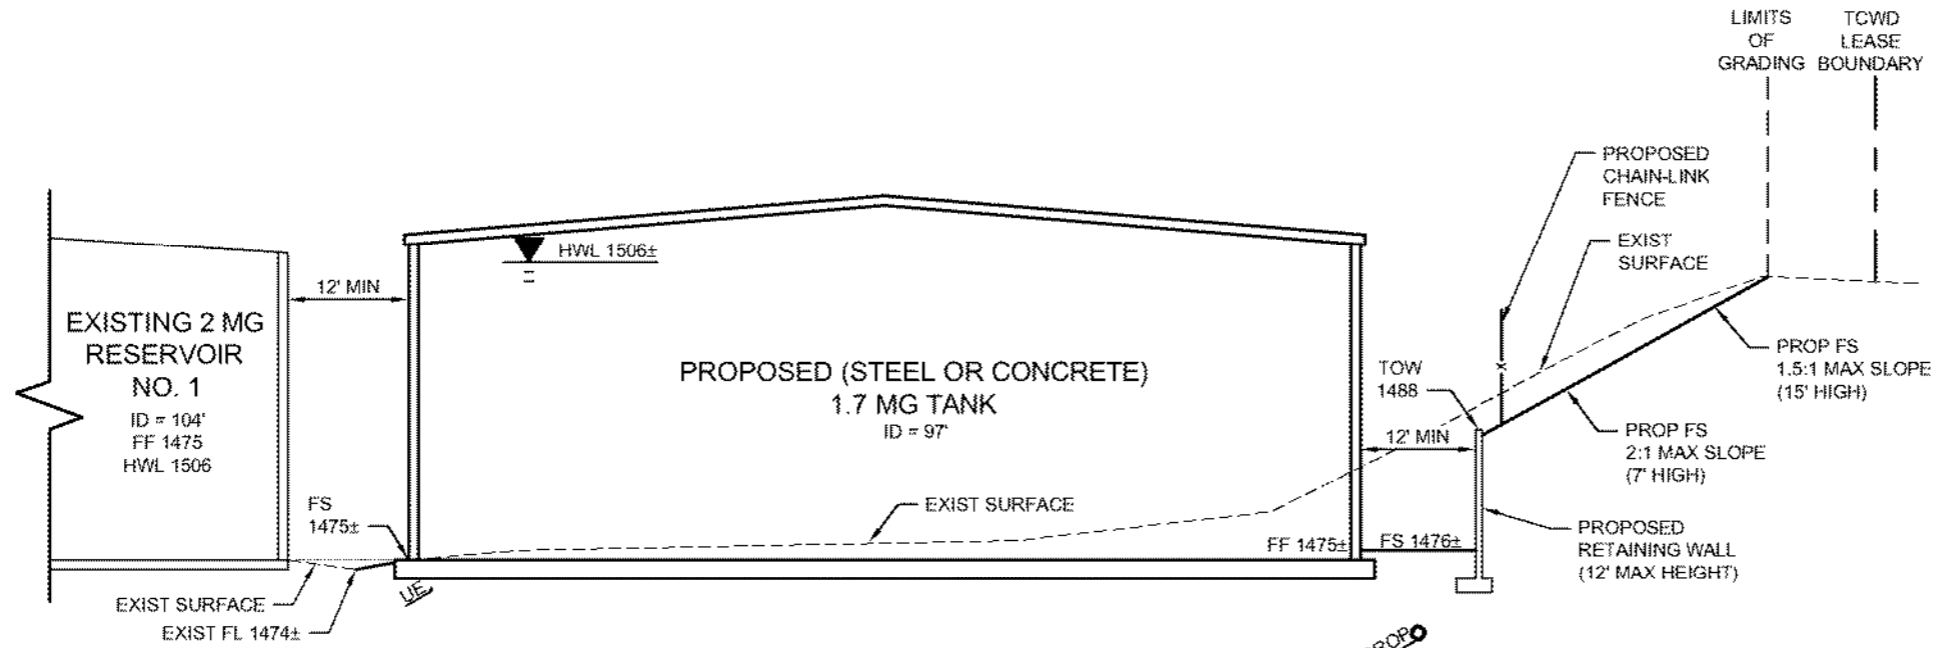
1 1.7 MG TANK SECTION  
SCALE: 1"=20'

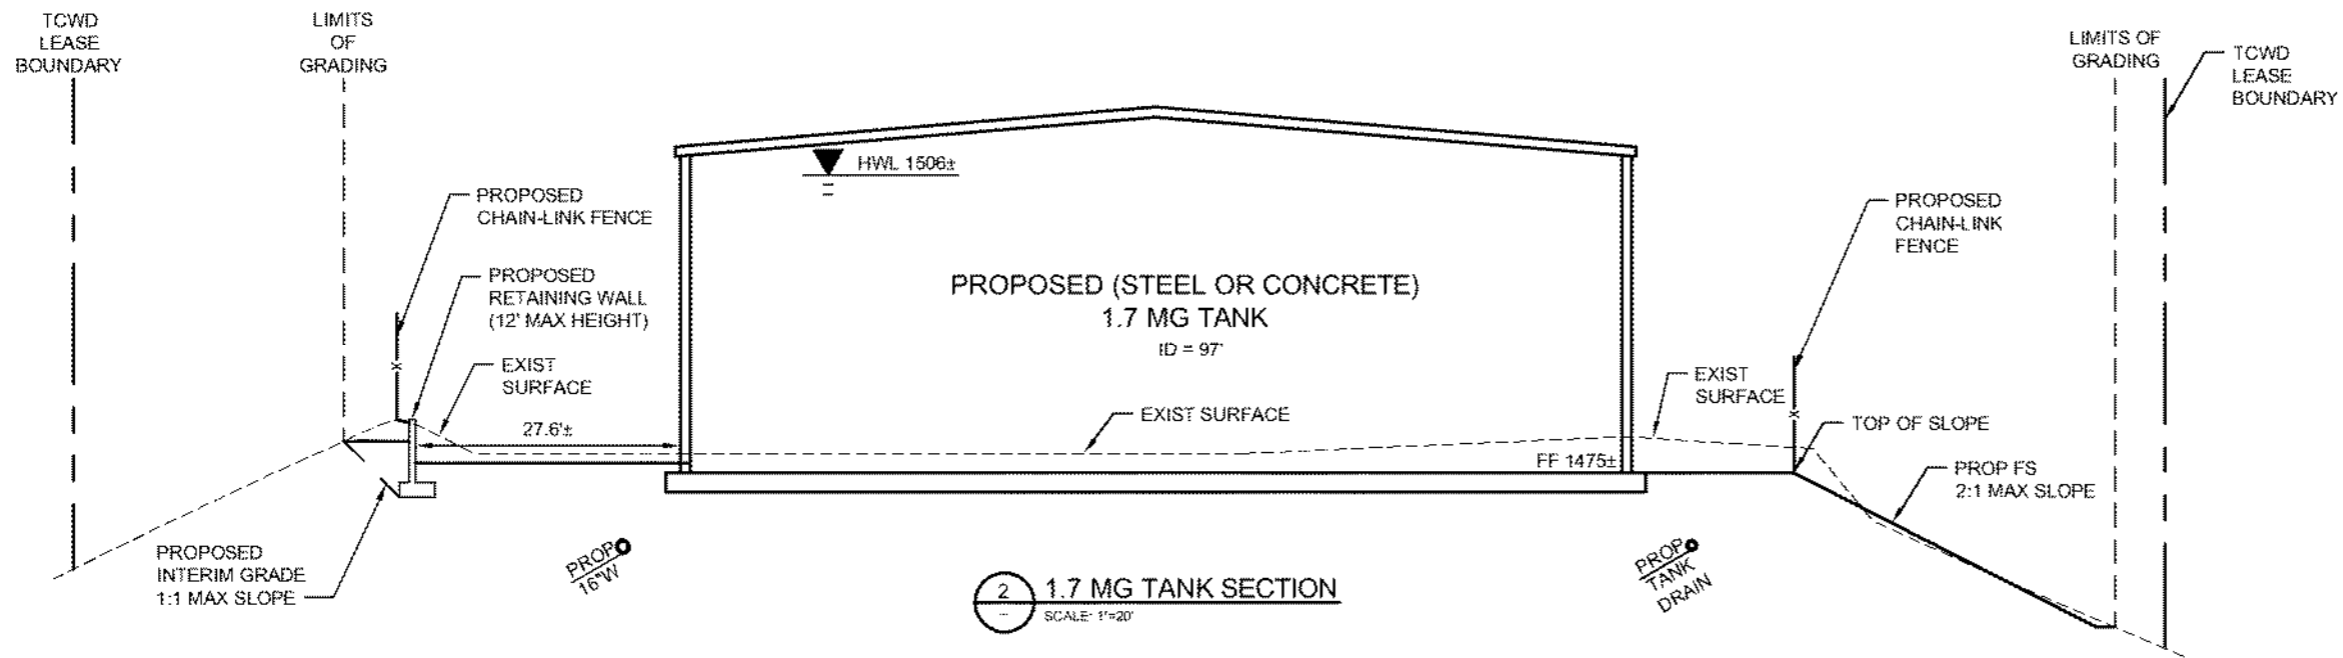
2 1.7 MG TANK SECTION  
SCALE: 1"=20'

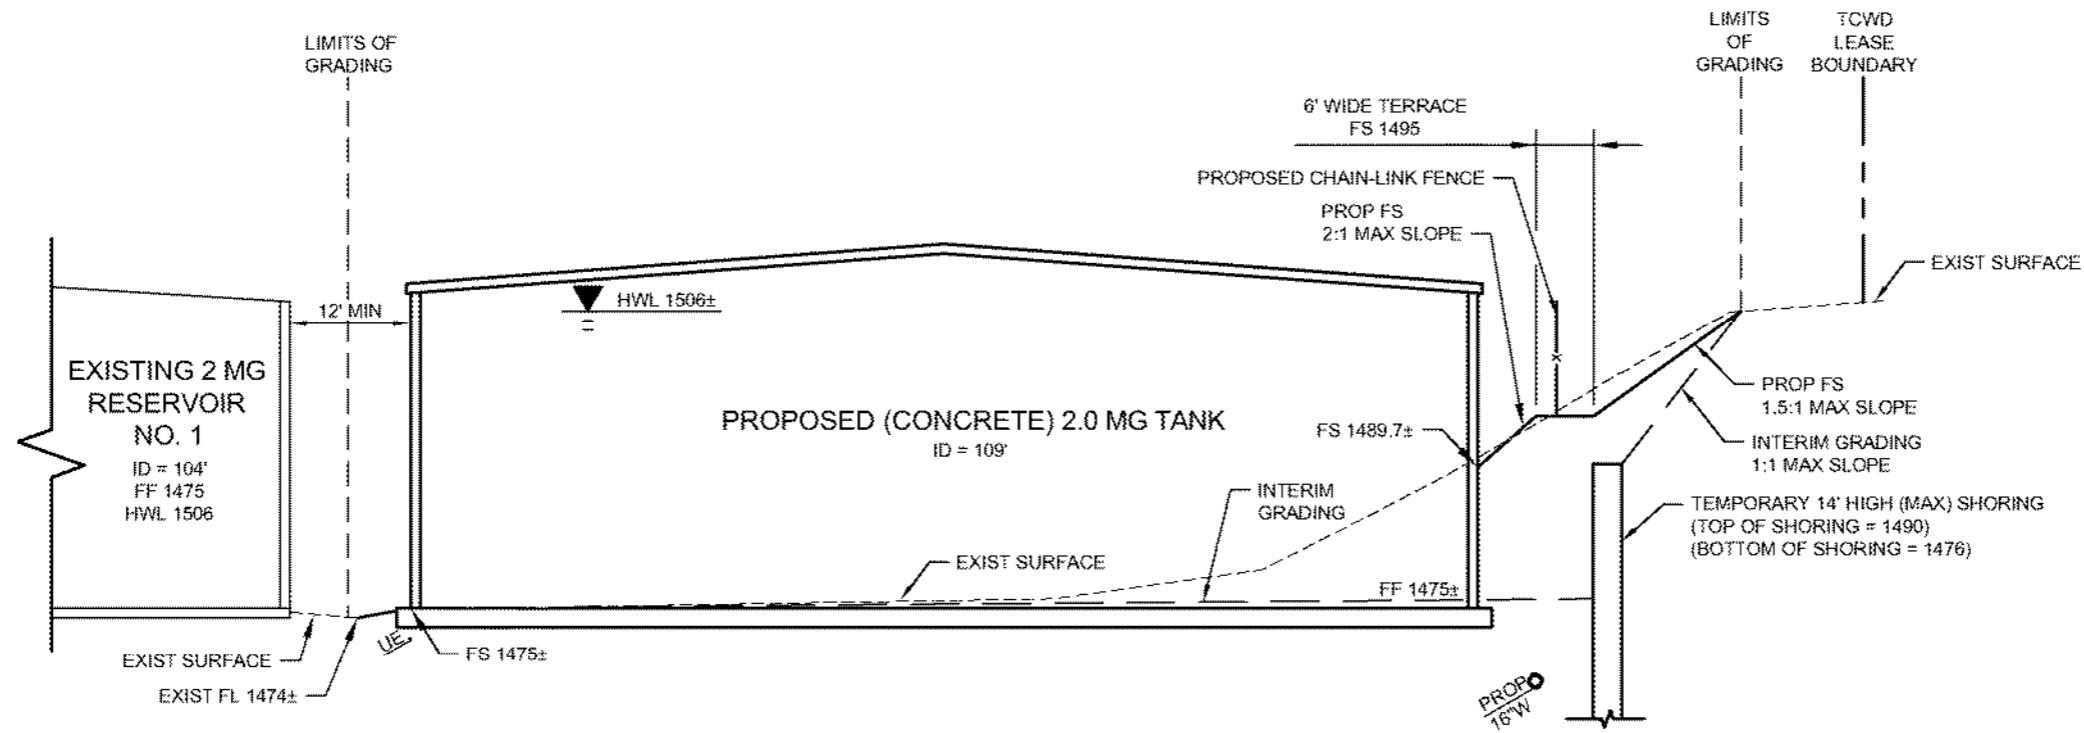
1 2.0 MG TANK SECTION  
SCALE: 1"=20'

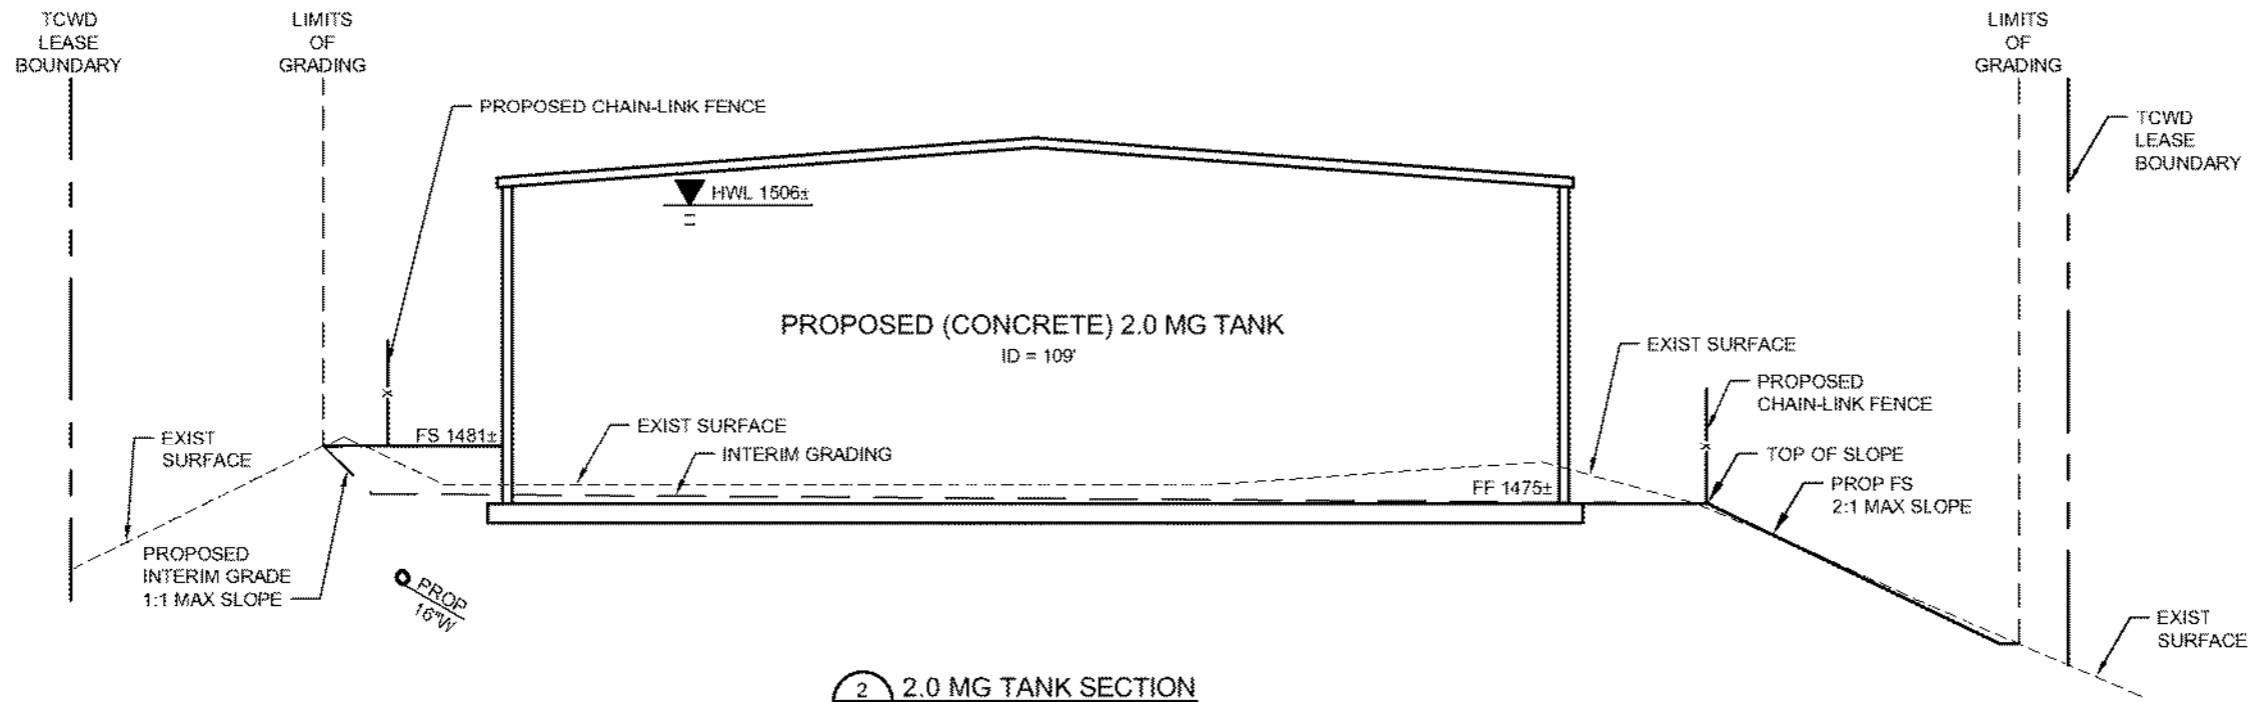
2 2.0 MG TANK SECTION  
SCALE: 1"=20'

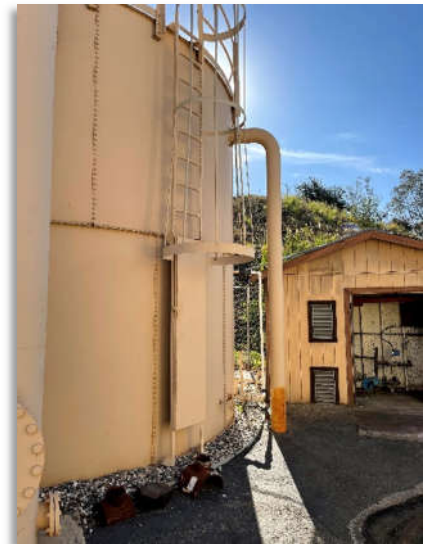
*Photo 1 – Existing 42,000-Gallon Backwash Settling Tank*

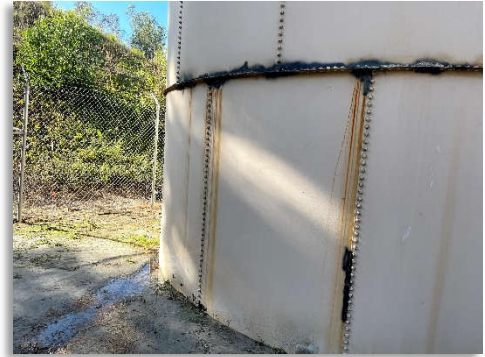
In its current condition, the shell for the southerly tank is corroded and has leaked in several locations (see **Photo 2**). This tank appears to be in poor shape and must be replaced immediately.

**Photo 2 – Corroded Shell of Southerly Backwash Settling Tank**

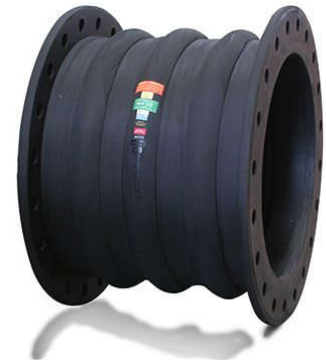
Further, a minimum 2-inch of flexibility in the vertical and tangential directions in either direction from the pipe centerline shall be provided for all piping attached to the tank shell. The required piping flexibility will be afforded via expansion joint such as Proco Style FA233L with limit rods (see **Photo 3**).

*Photo 3 – Piping Expansion Joint  
Proco Style FA233L*

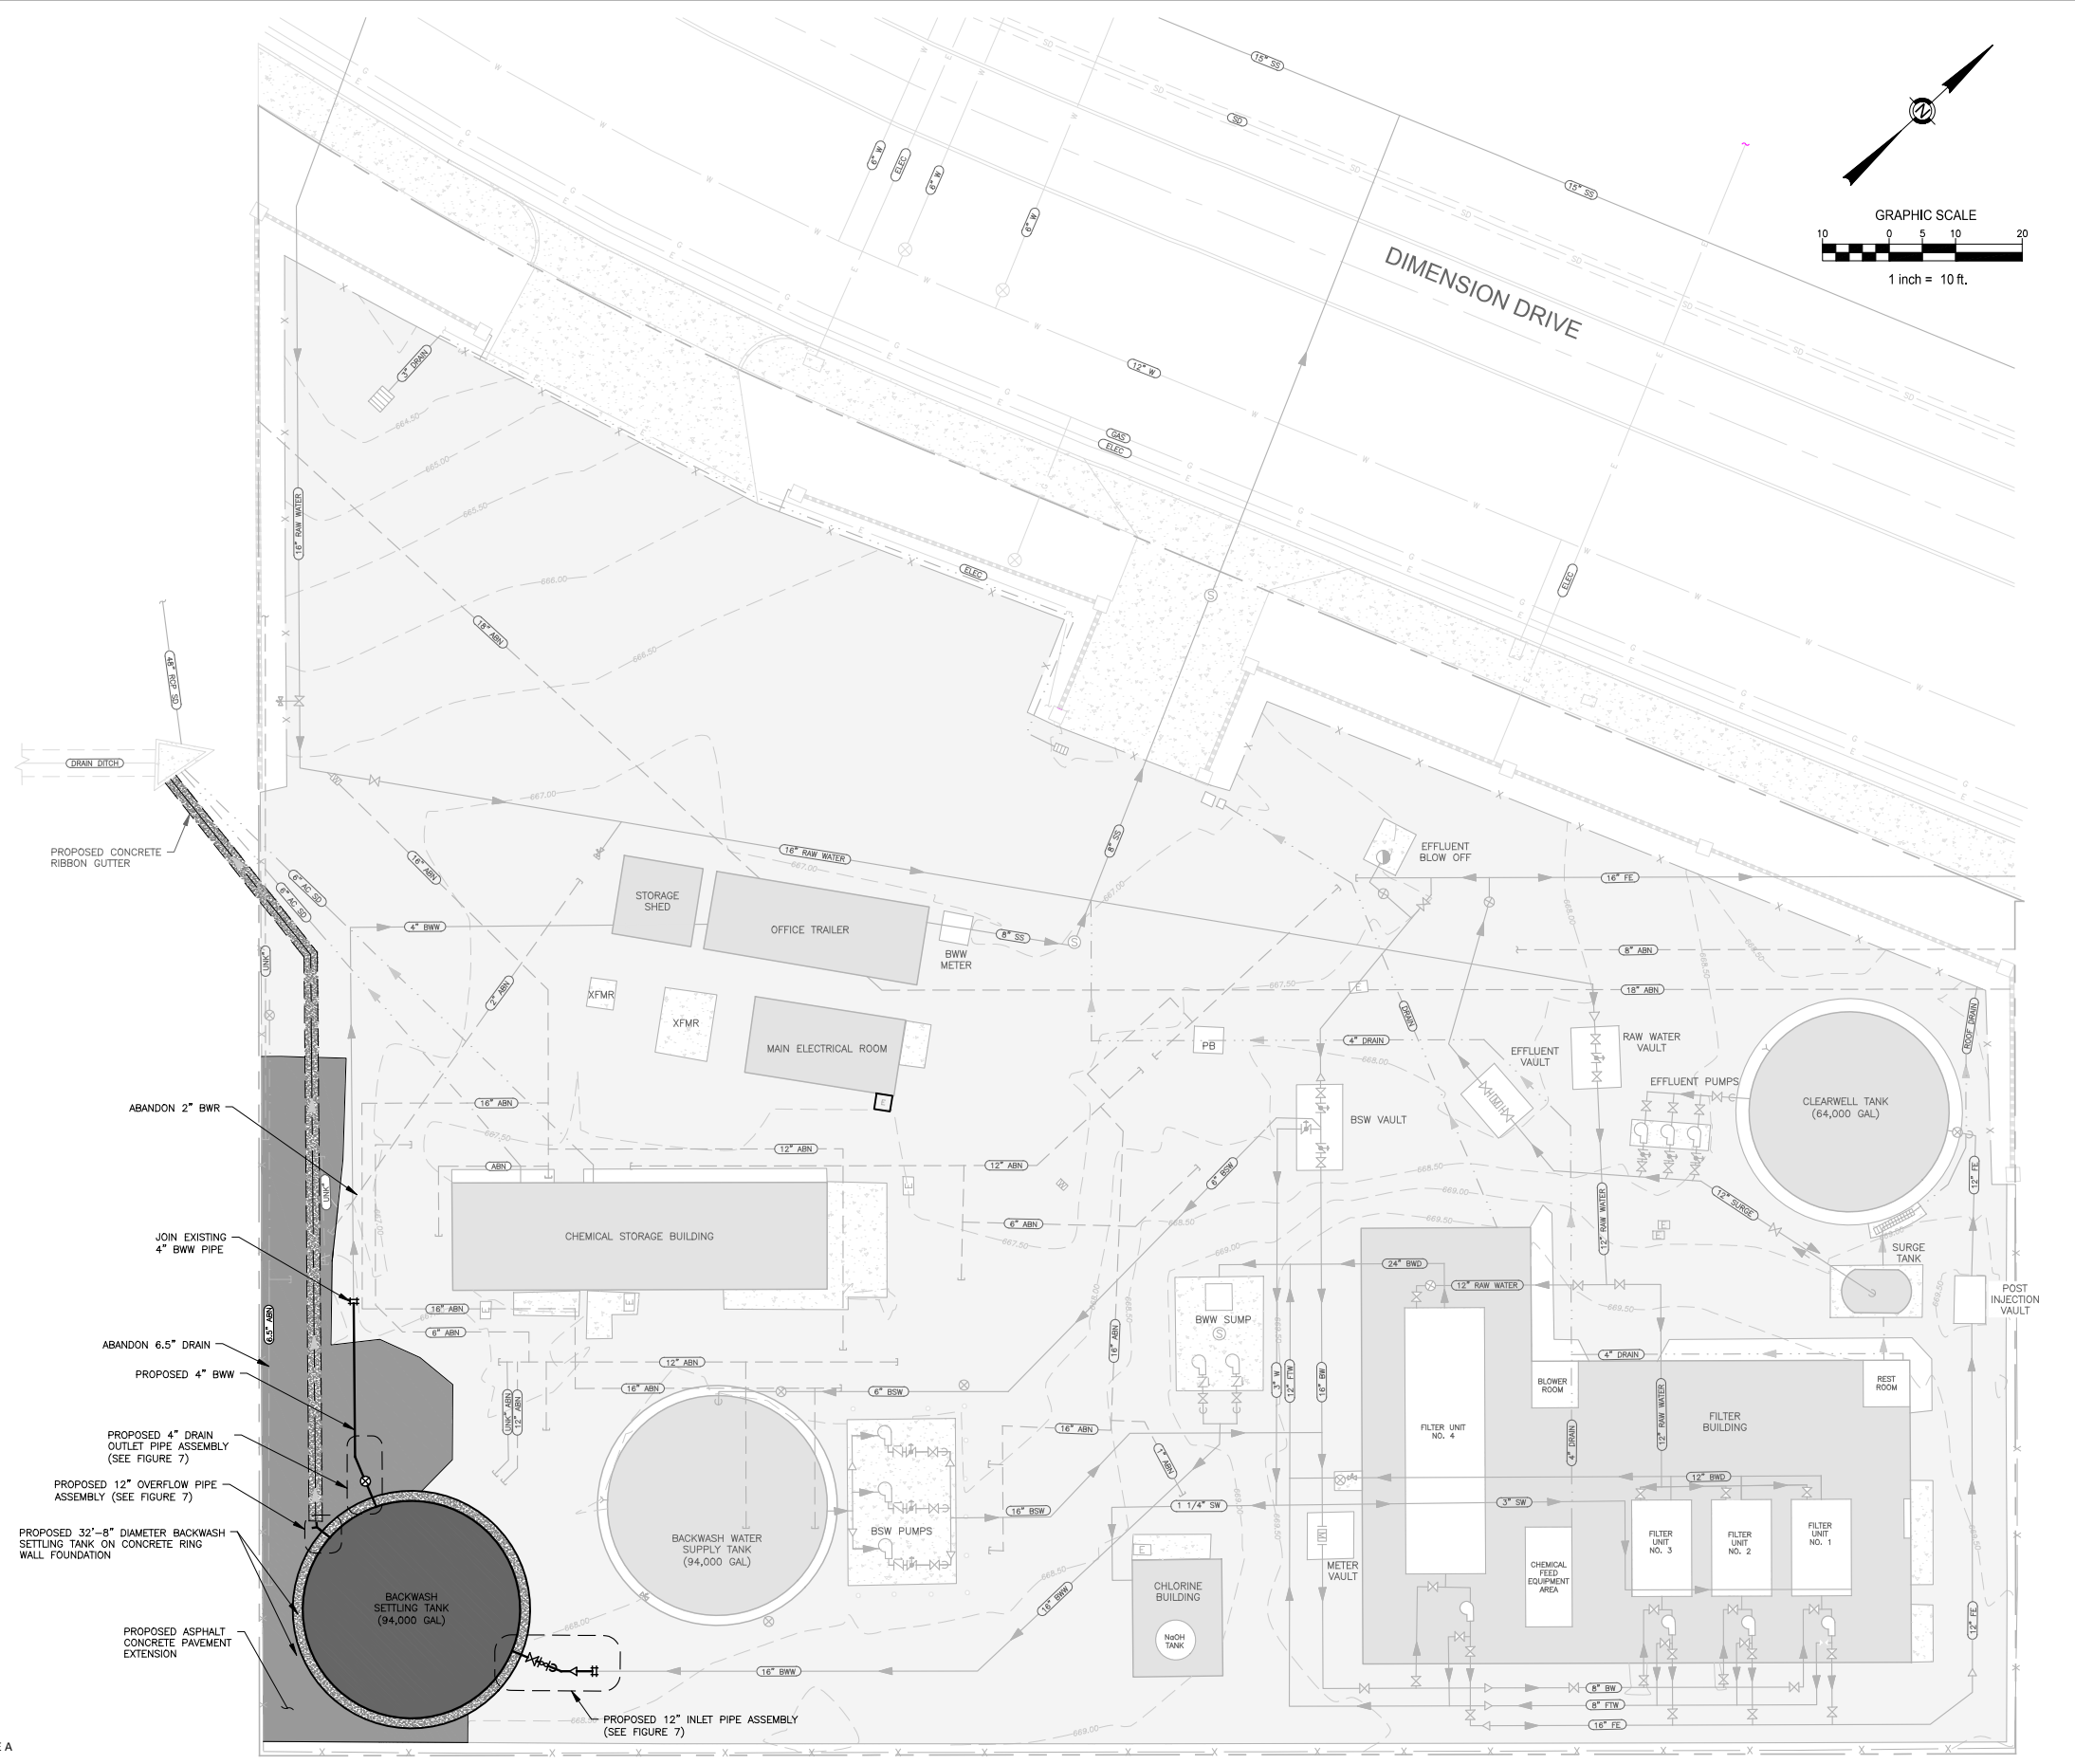
- ABANDON 2" BWR
- JOIN EXISTING 4" BWW PIPE
- ABANDON 6.5" DRAIN
- PROPOSED 4" BWW
- PROPOSED 4" DRAIN OUTLET PIPE ASSEMBLY (SEE FIGURE 7)
- PROPOSED 12" OVERFLOW PIPE ASSEMBLY (SEE FIGURE 7)
- PROPOSED 32"-8" DIAMETER BACKWASH SETTLING TANK ON CONCRETE RING WALL FOUNDATION
- PROPOSED ASPHALT CONCRETE PAVEMENT EXTENSION
- PROPOSED 12" INLET PIPE ASSEMBLY (SEE FIGURE 7)

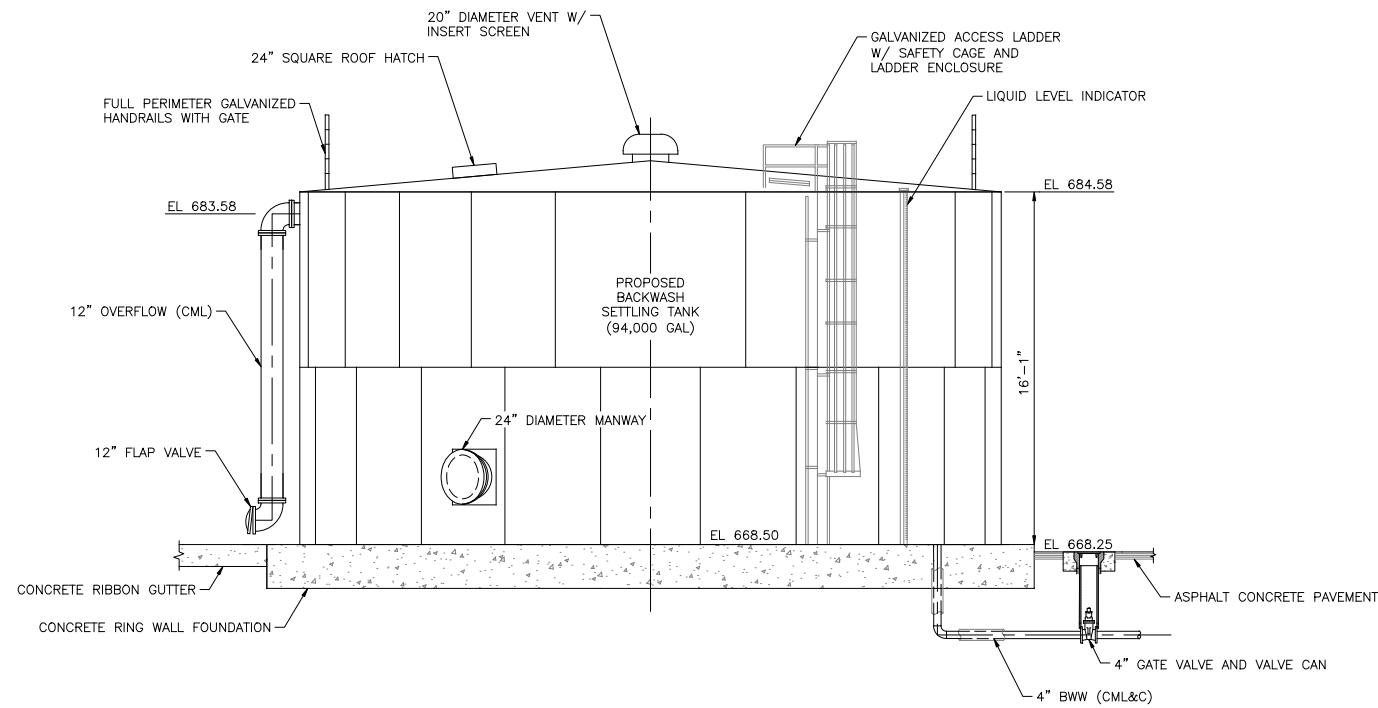
**BACKWASH SETTLING TANK SECTION**

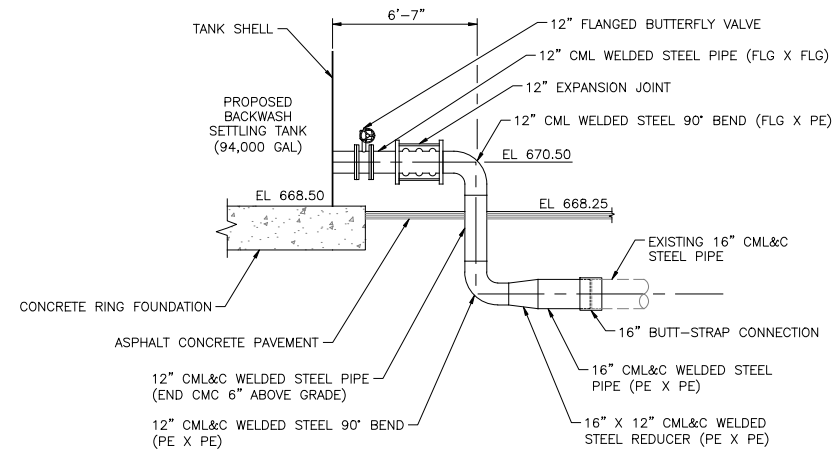
**BACKWASH SETTLING TANK  
INLET PIPE ASSEMBLY**

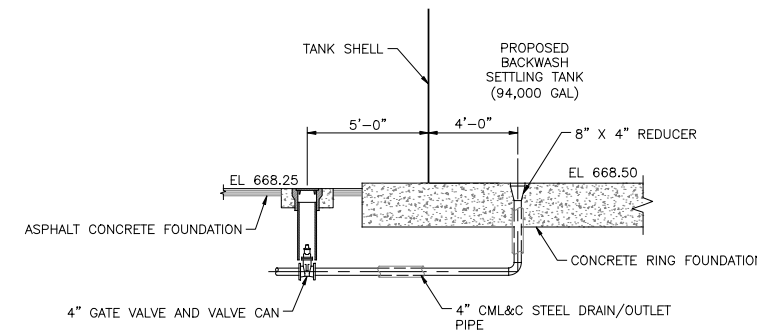
**BACKWASH SETTLING TANK  
DRAIN/OUTLET PIPE ASSEMBLY**
